AFML-TR-79-4209

FATIGUE CRACK PROPAGATION AND CORROSION
FATIGUE OF AF 1410 STEEL

S. D. ANTOLOVICH

JANUARY 1980

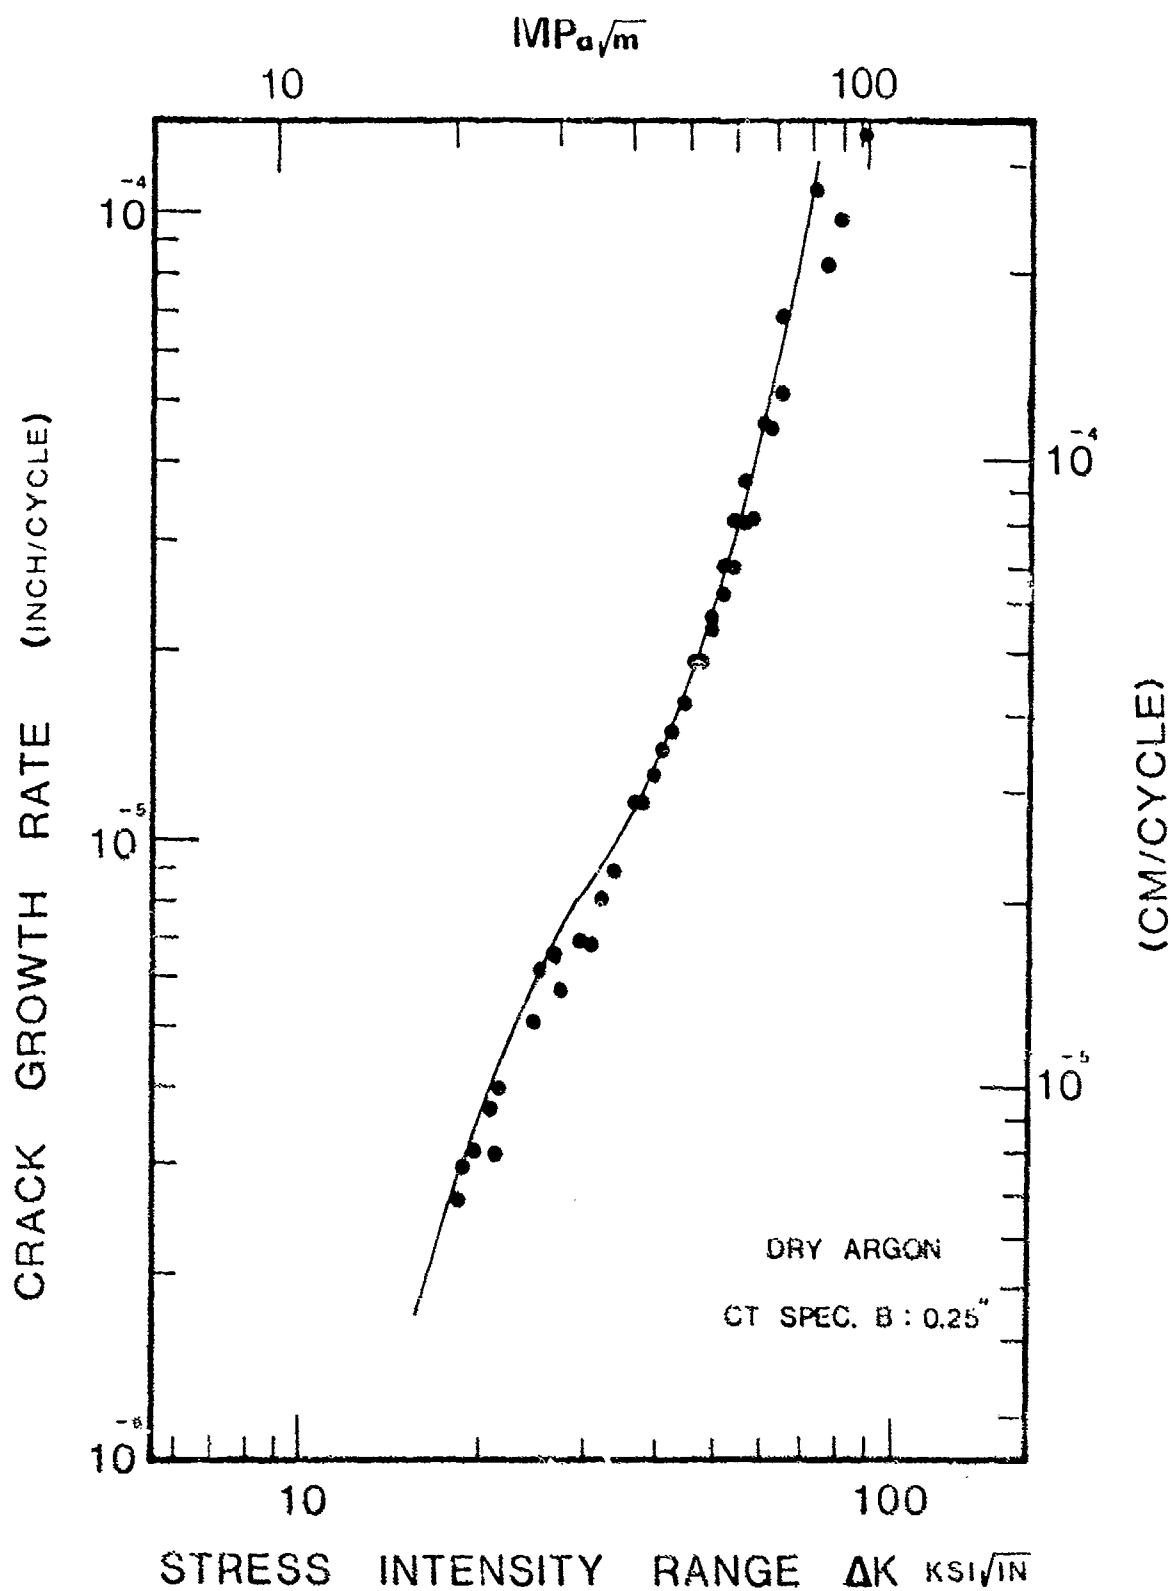
Fig. 13. Fatigue crack growth rate versus stress intensity range for AF 1410 steel, 950°F/5 hrs. age, tested at 10 Hz. and $R = 0.1$.

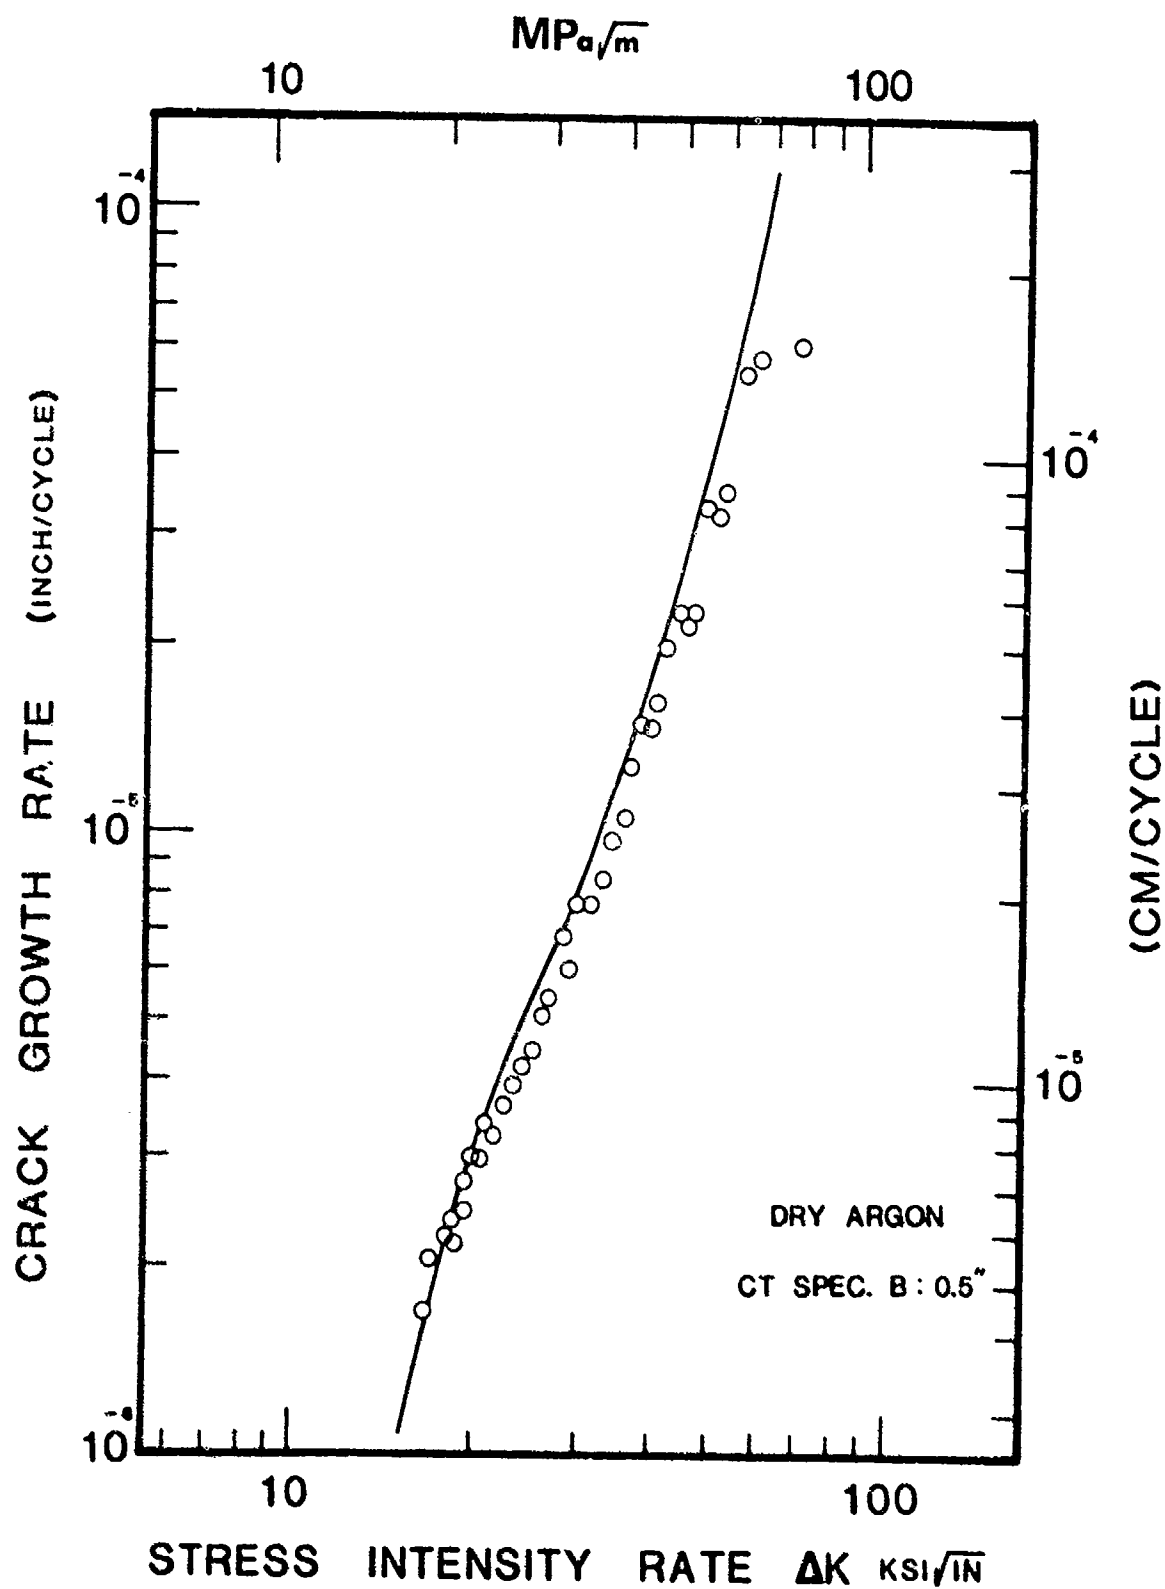
Fig. 14. Fatigue crack growth rate versus stress intensity range for AF 14°C steel, 950°F/5 hrs. age, tested at 10 Hz. and $R = 0.1$.

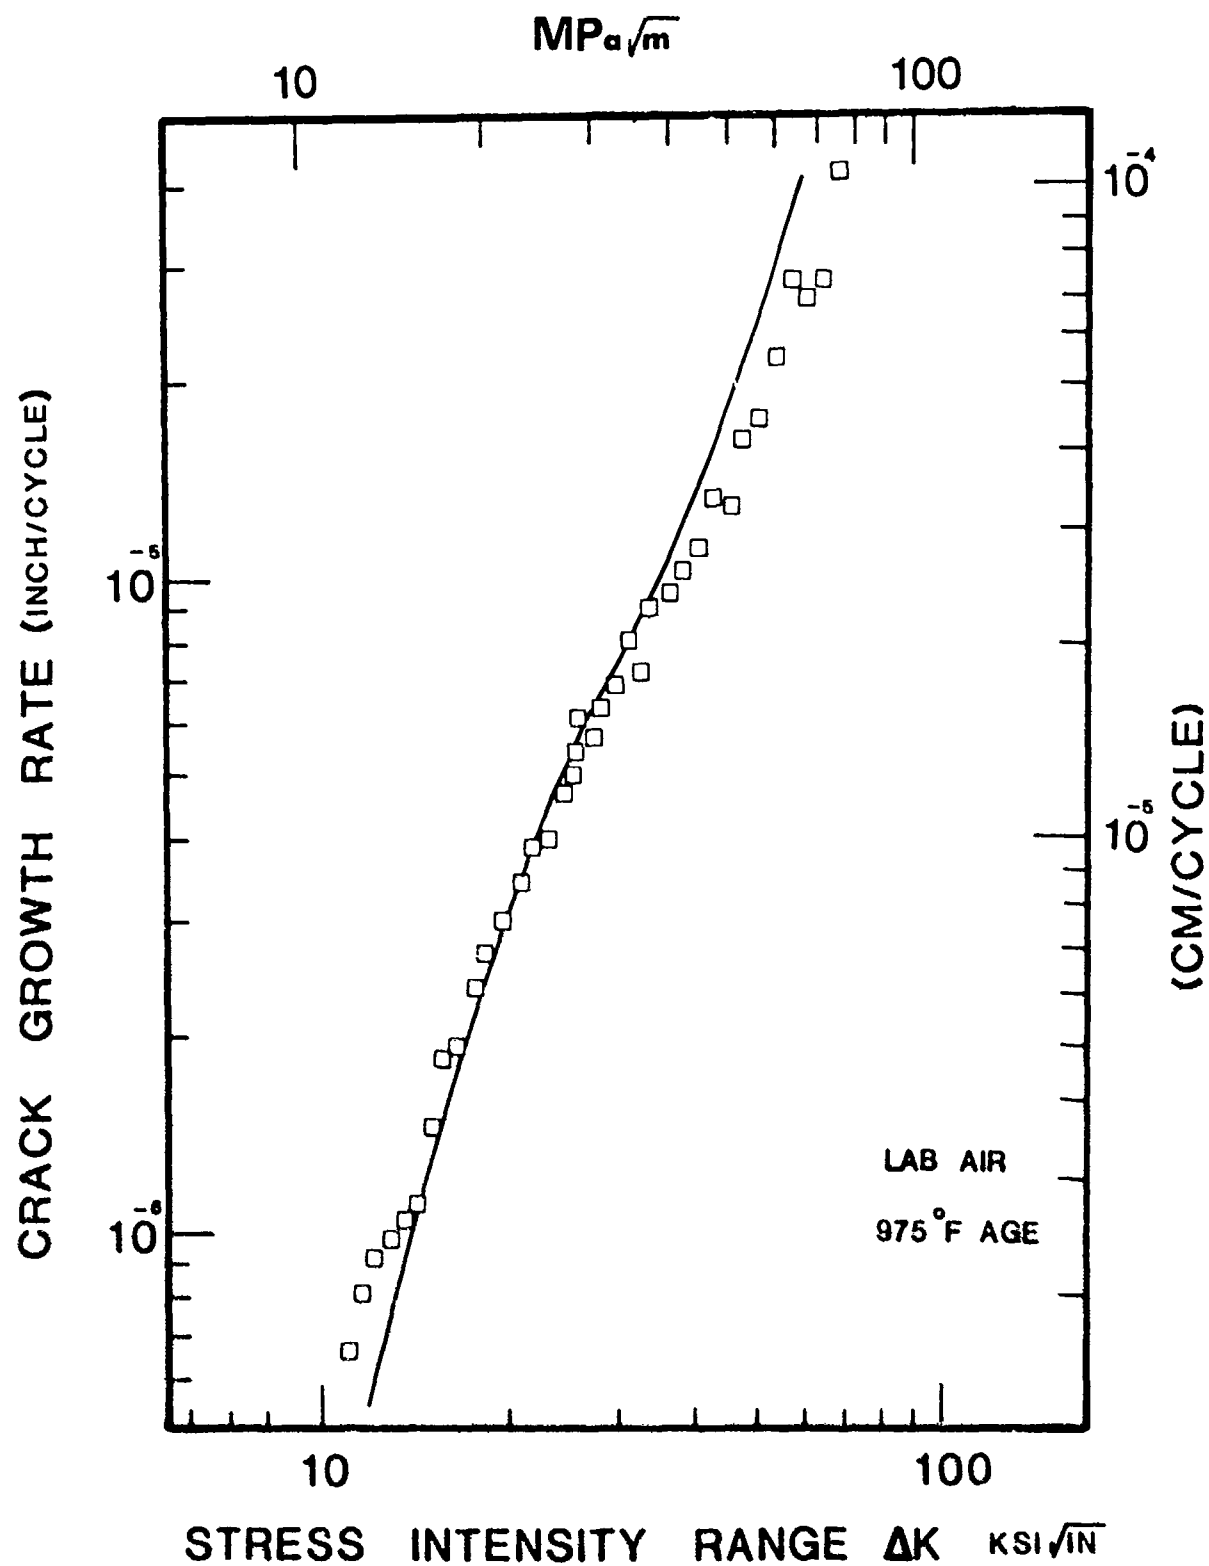
Fig. 15. Fatigue crack growth rate versus stress intensity range for AF 1410 steel aged 5 hrs. at 975°F, tested at $f = 10$ Hz. and $R = 0.1$. SEN specimen, $B = 0.08$ ".

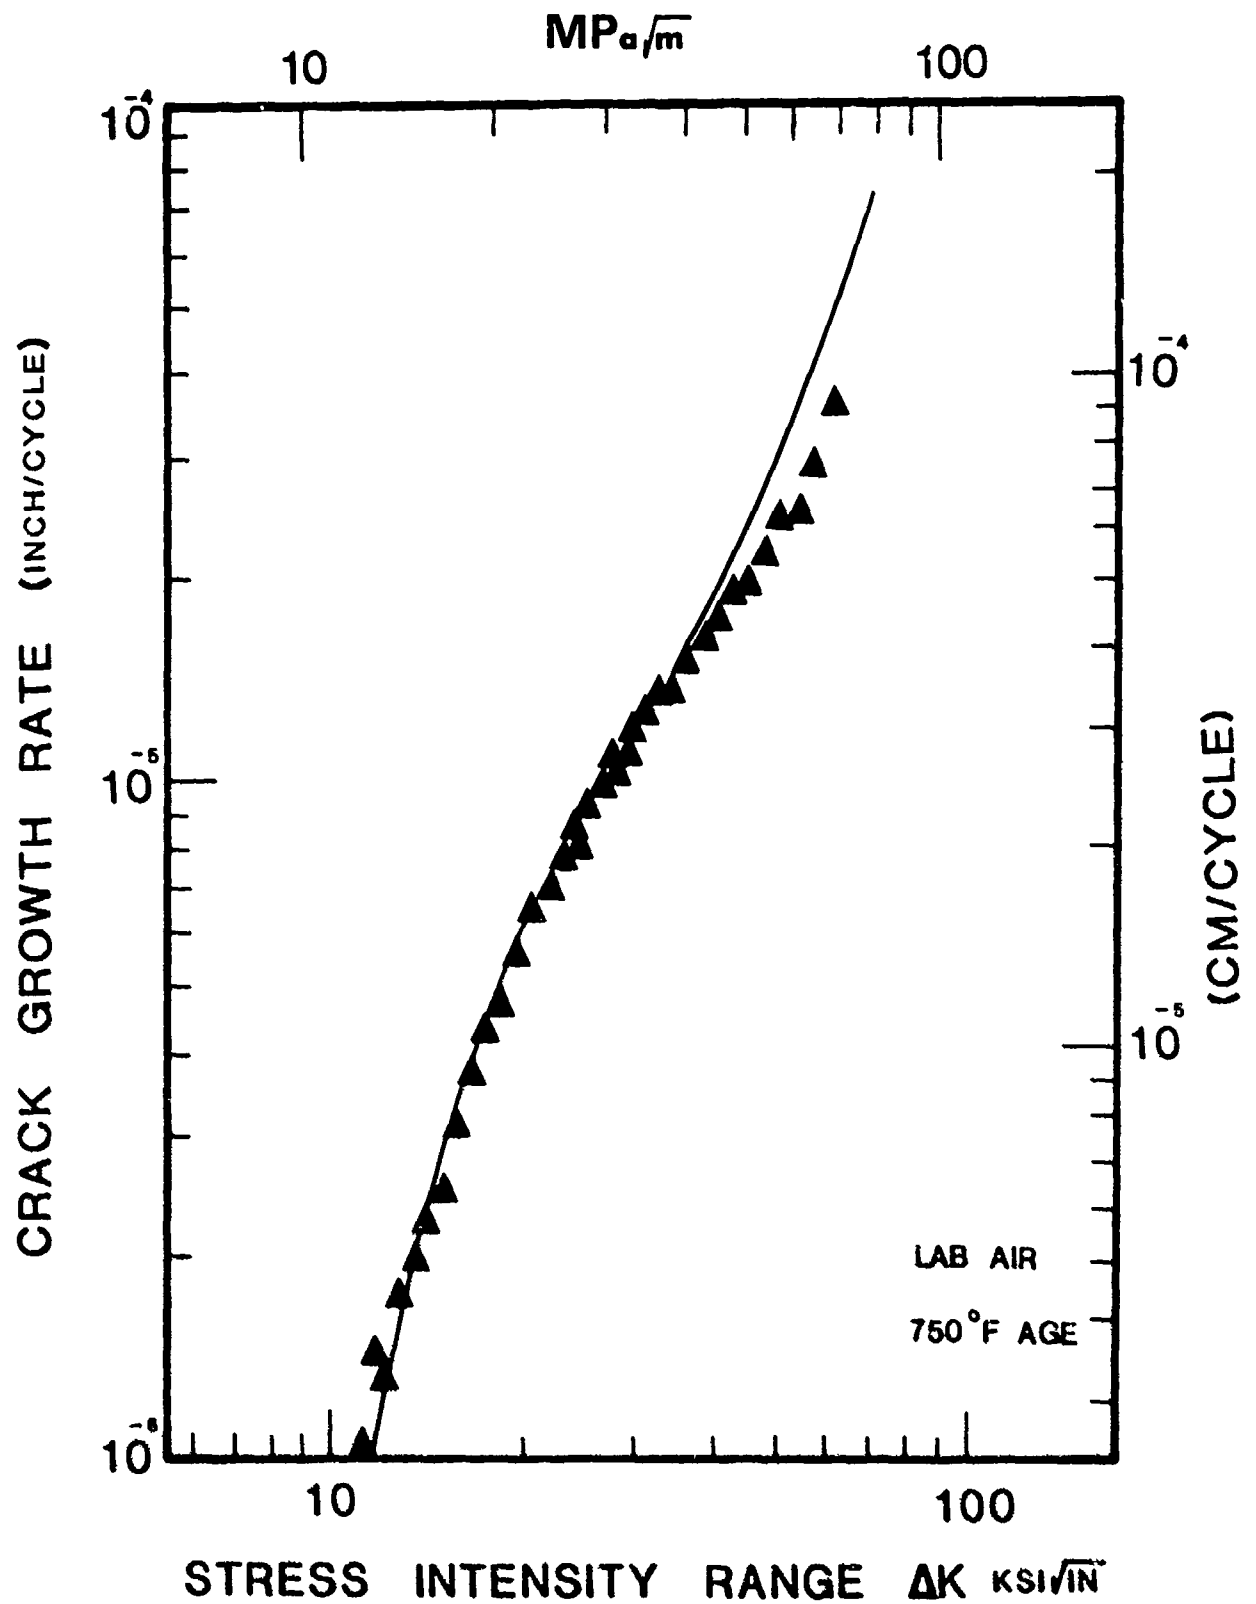
Fig. 16. Fatigue crack growth rate versus stress intensity range for AF 1410 steel aged 5 hrs. at 750°F, tested at 10 Hz. and $R = 0.1$. SEN specimens, $B = 0.08$ "

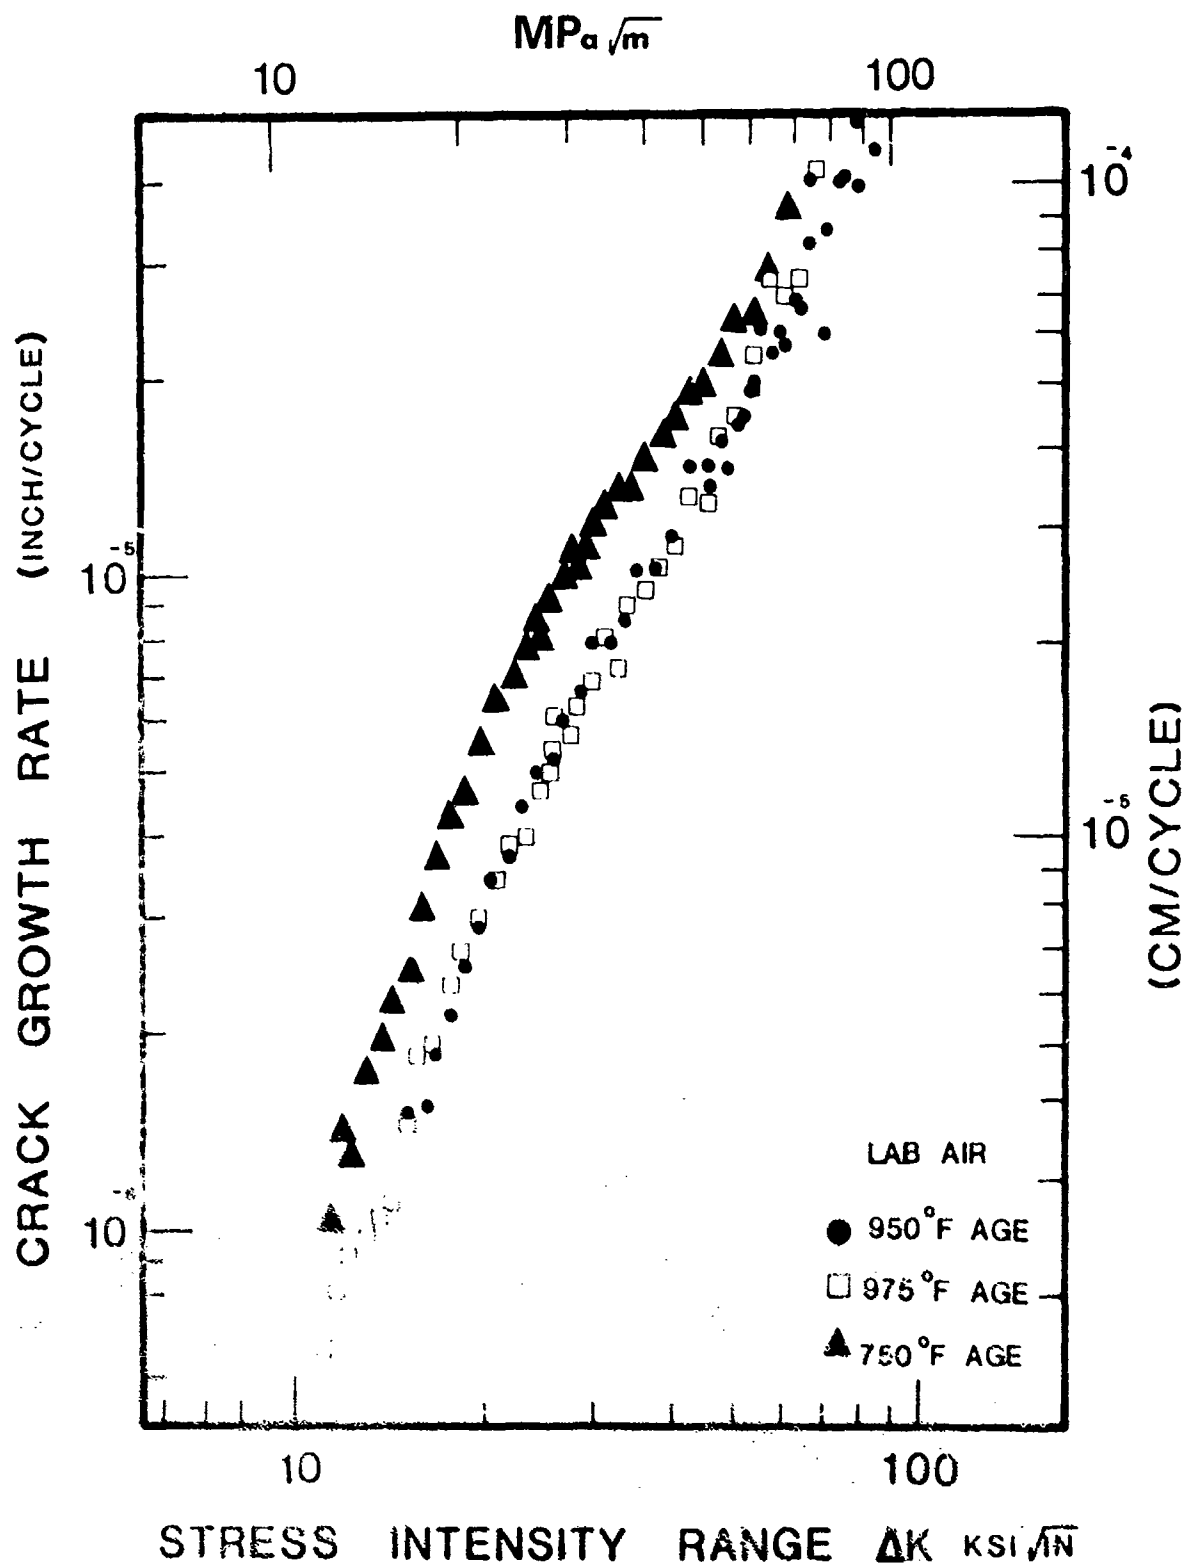
Fig. 17. Effect of ageing temperature on fatigue crack growth rate of AF-1410 steel. All tests run at 10 Hz. and $R = 0.1$. SEN specimens, $B = 0.08$.

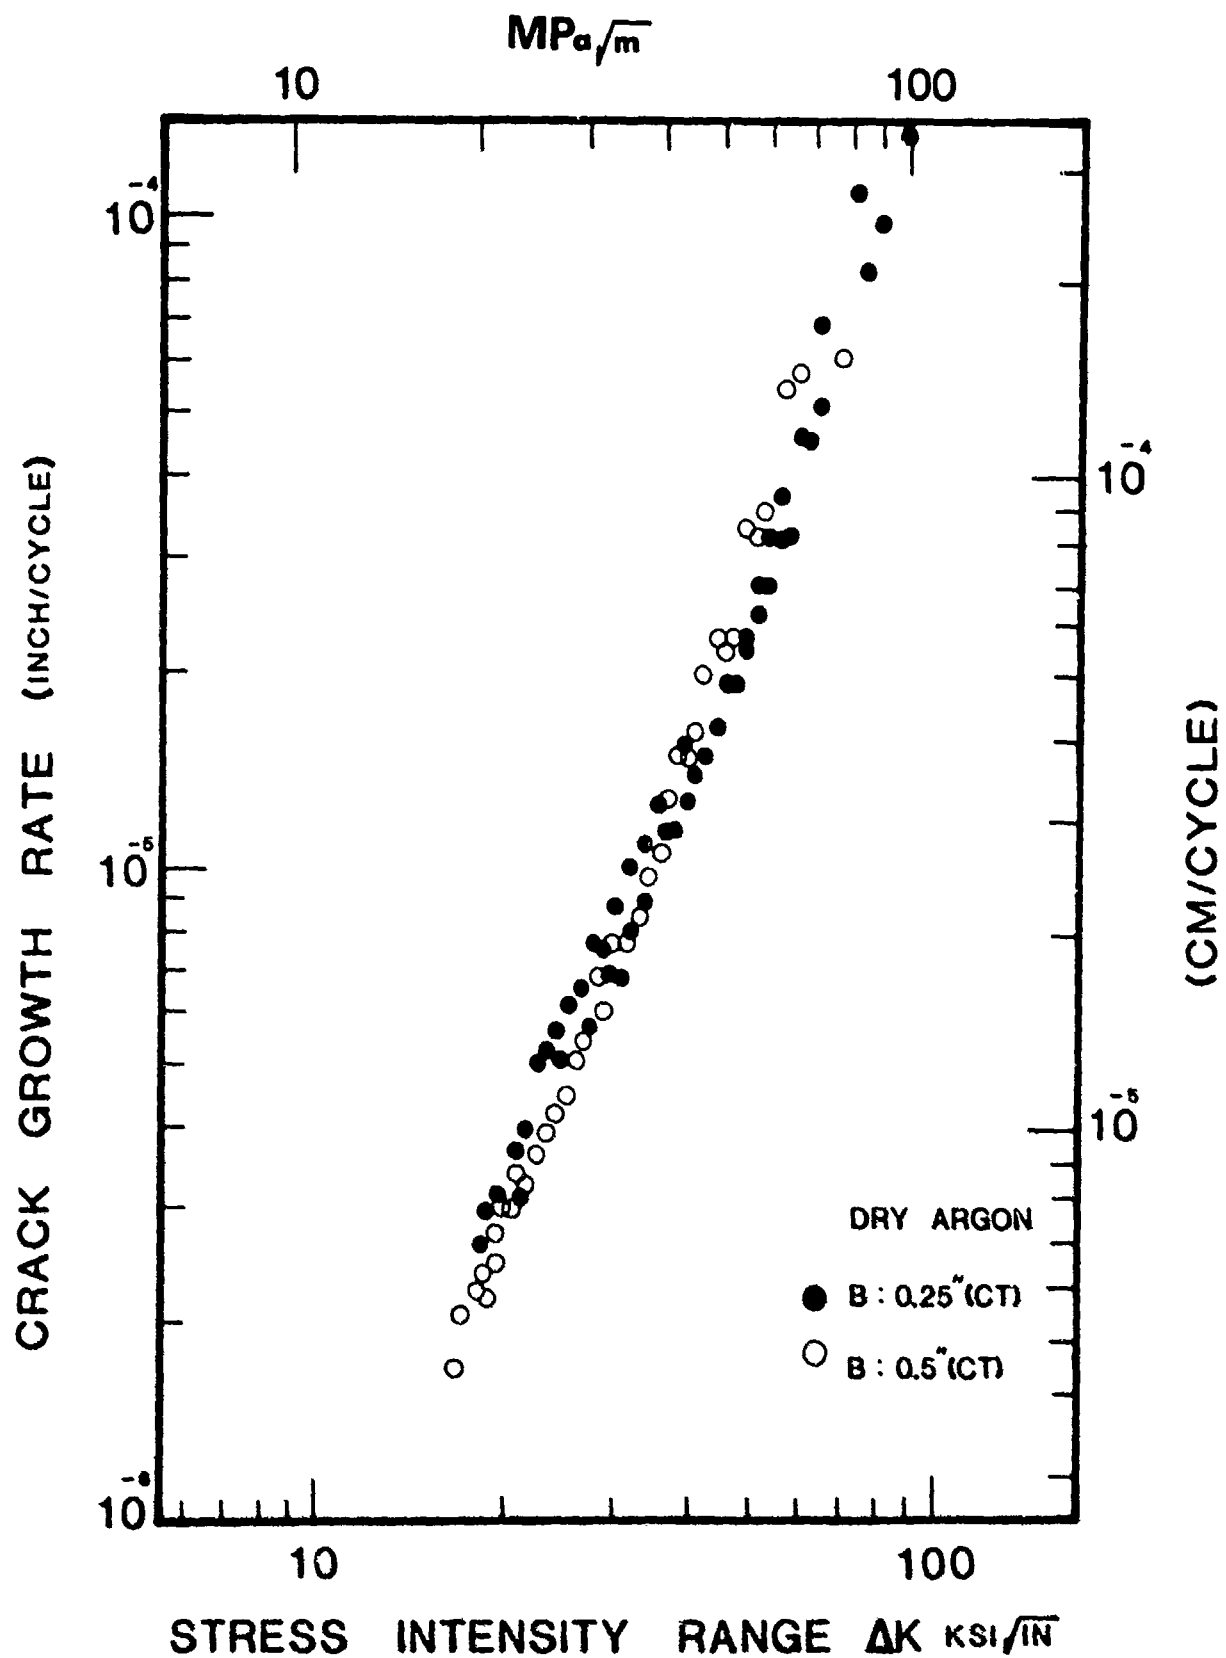
Fig. 18. Effect of thickness on fatigue crack growth rate of AF-1410 steel, 950°F/5 hrs. age, tested at 10 Hz. and R = 0.1.

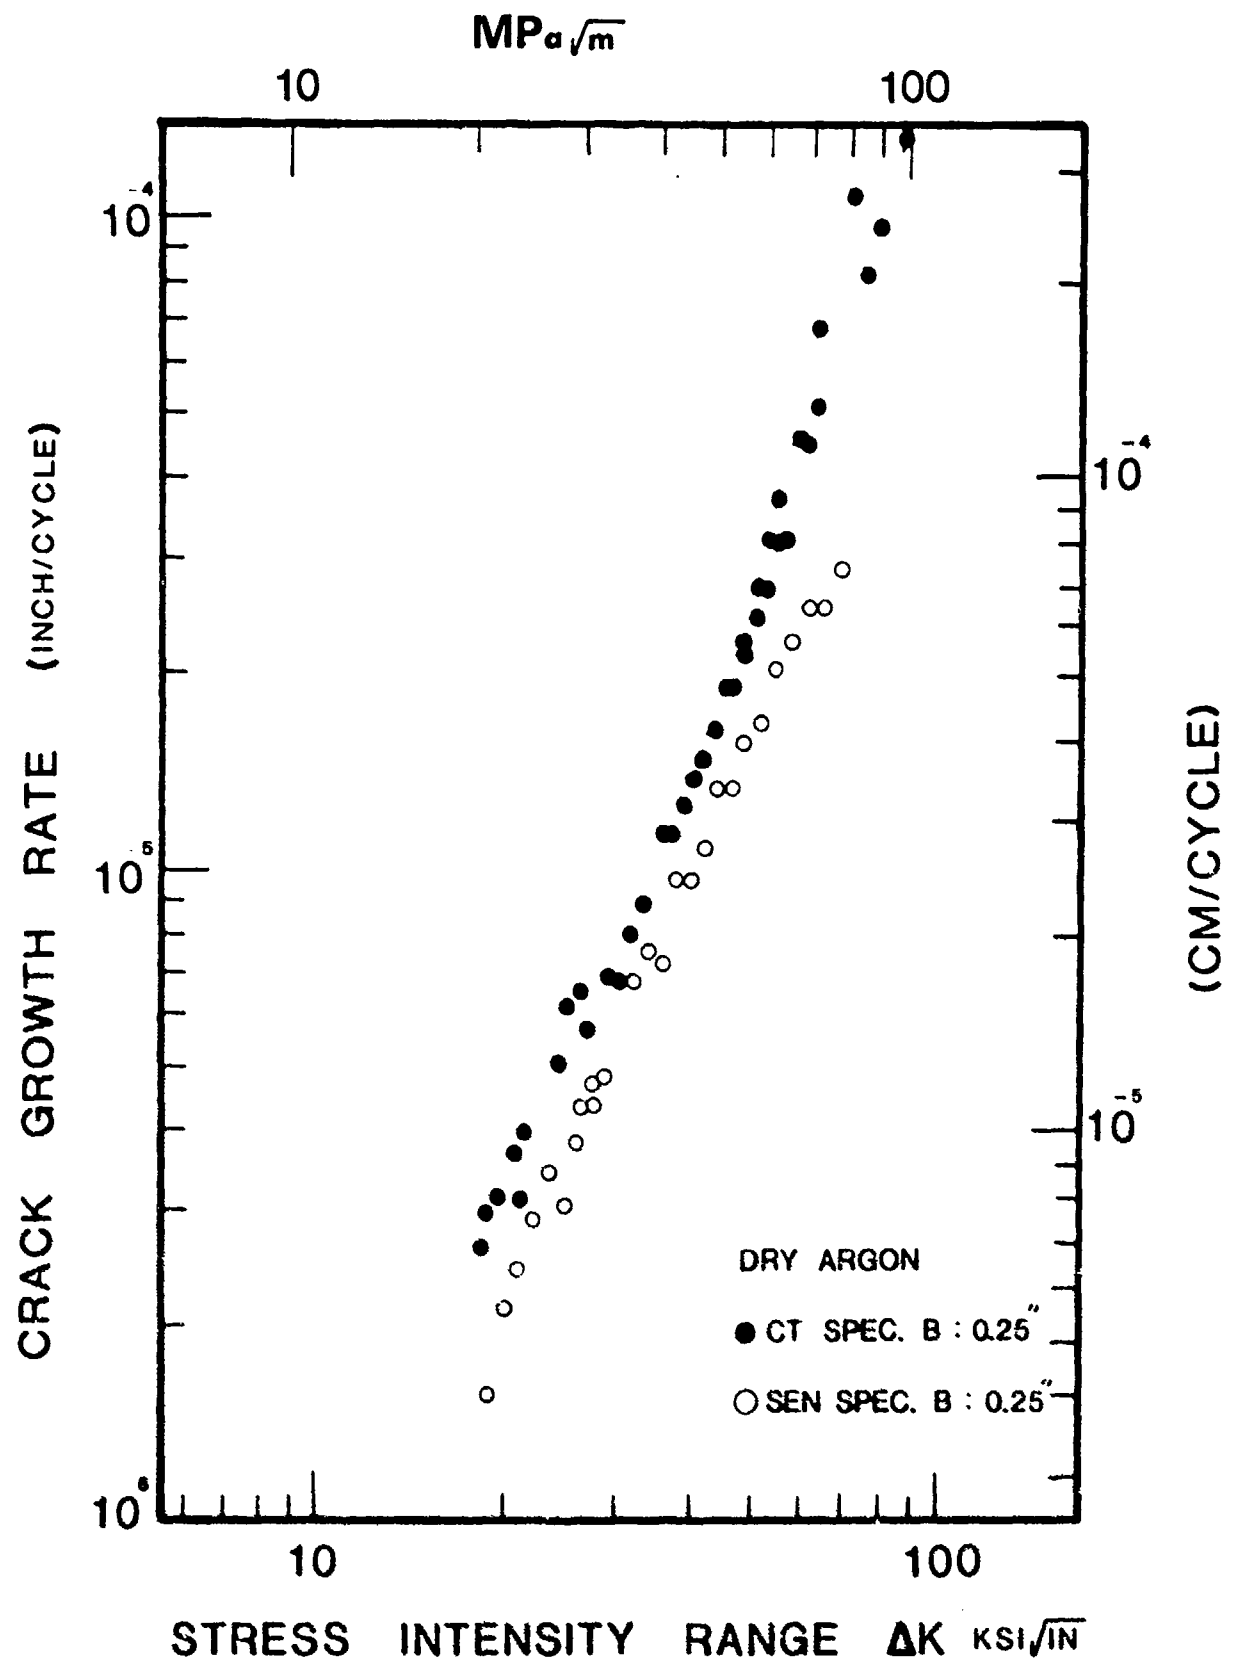
Fig. 19. Effect of specimen geometry on fatigue crack growth rate of AF-1410 steel, 950°F/5 hrs. age, tested at 10 Hz. and $R = 0.1$.
